**FOURTH FIVE-YEAR REVIEW REPORT FOR
RAYMARK SUPERFUND SITE
MONTGOMERY COUNTY, PENNSYLVANIA**

September 2014

**Prepared by
U.S. Environmental Protection Agency
Region III
Philadelphia, Pennsylvania**

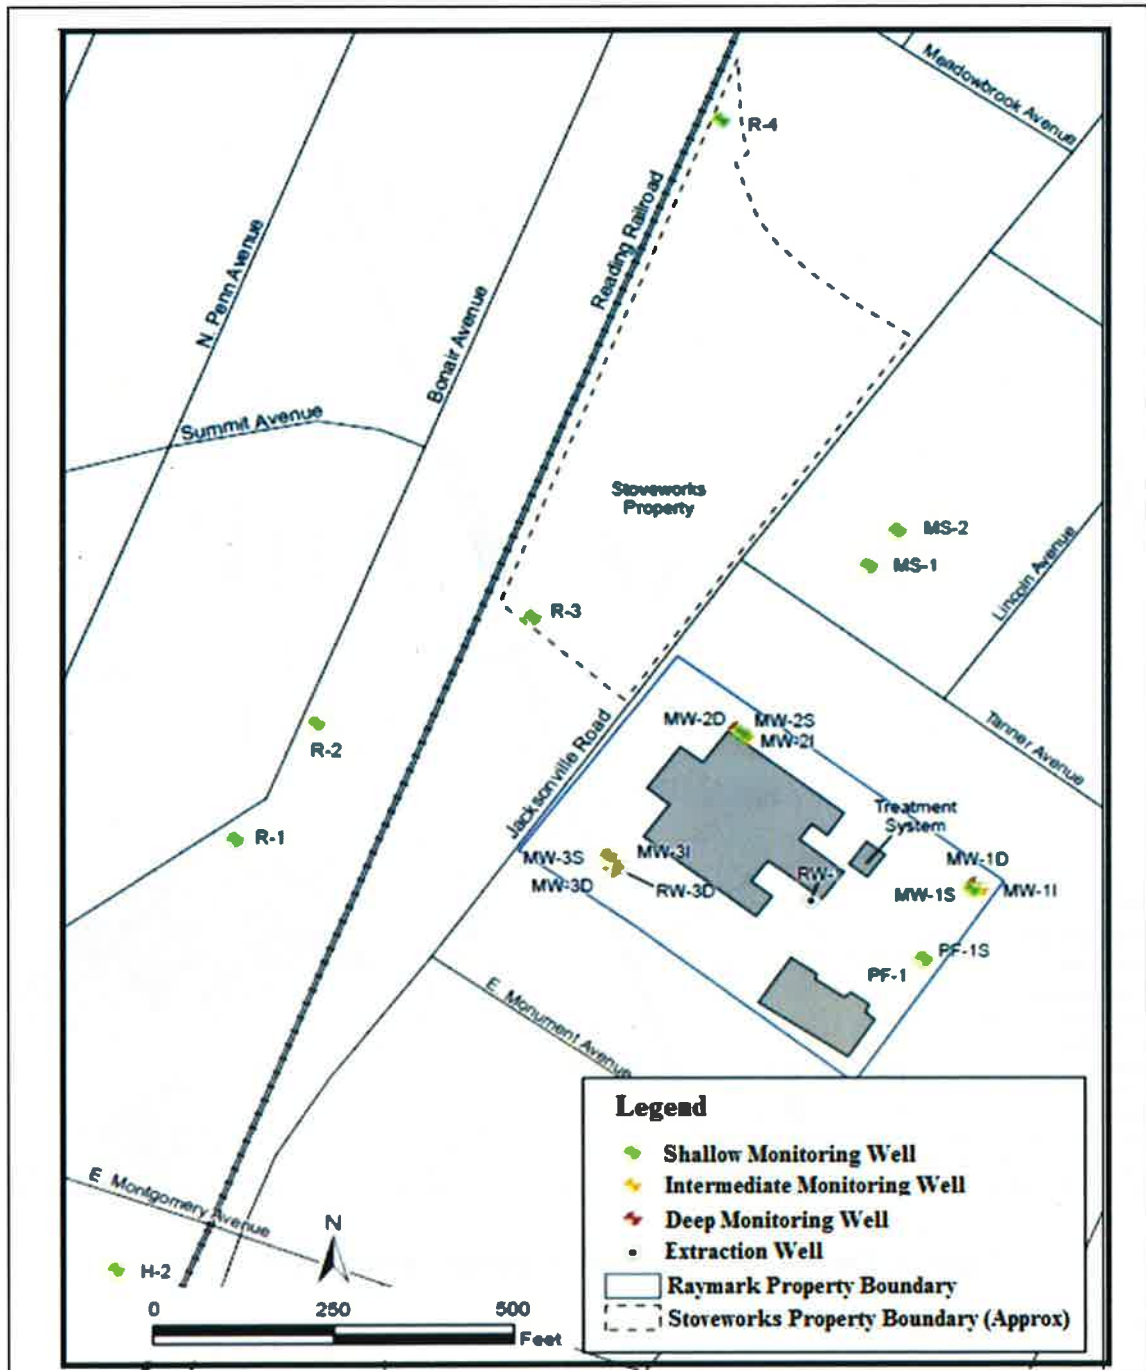
Figure 2. Site Map and Monitoring Wells at the Property

The groundwater was analyzed for volatile organic compounds. Well data from 2011 to 2013 indicates TCE continues to be present in groundwater throughout the Site. Two nested well sets (R1 and R2) were installed on Bonair Avenue in 2011 to delineate downgradient groundwater contamination and investigate the potential for vapor intrusion in nearby residences. TCE and its degradation product 1, 1-DCE were the only COCs that were detected in most wells (including the newly installed wells) above MCLs (1,1-DCE was found in MW-R1(D) above MCLs). TCE was the only COC detected in all wells at a concentration above the MCL. PCE was also detected in well in MW-2S, MW-3S and MW-3D above the MCL at some point since the last Five-Year Review.

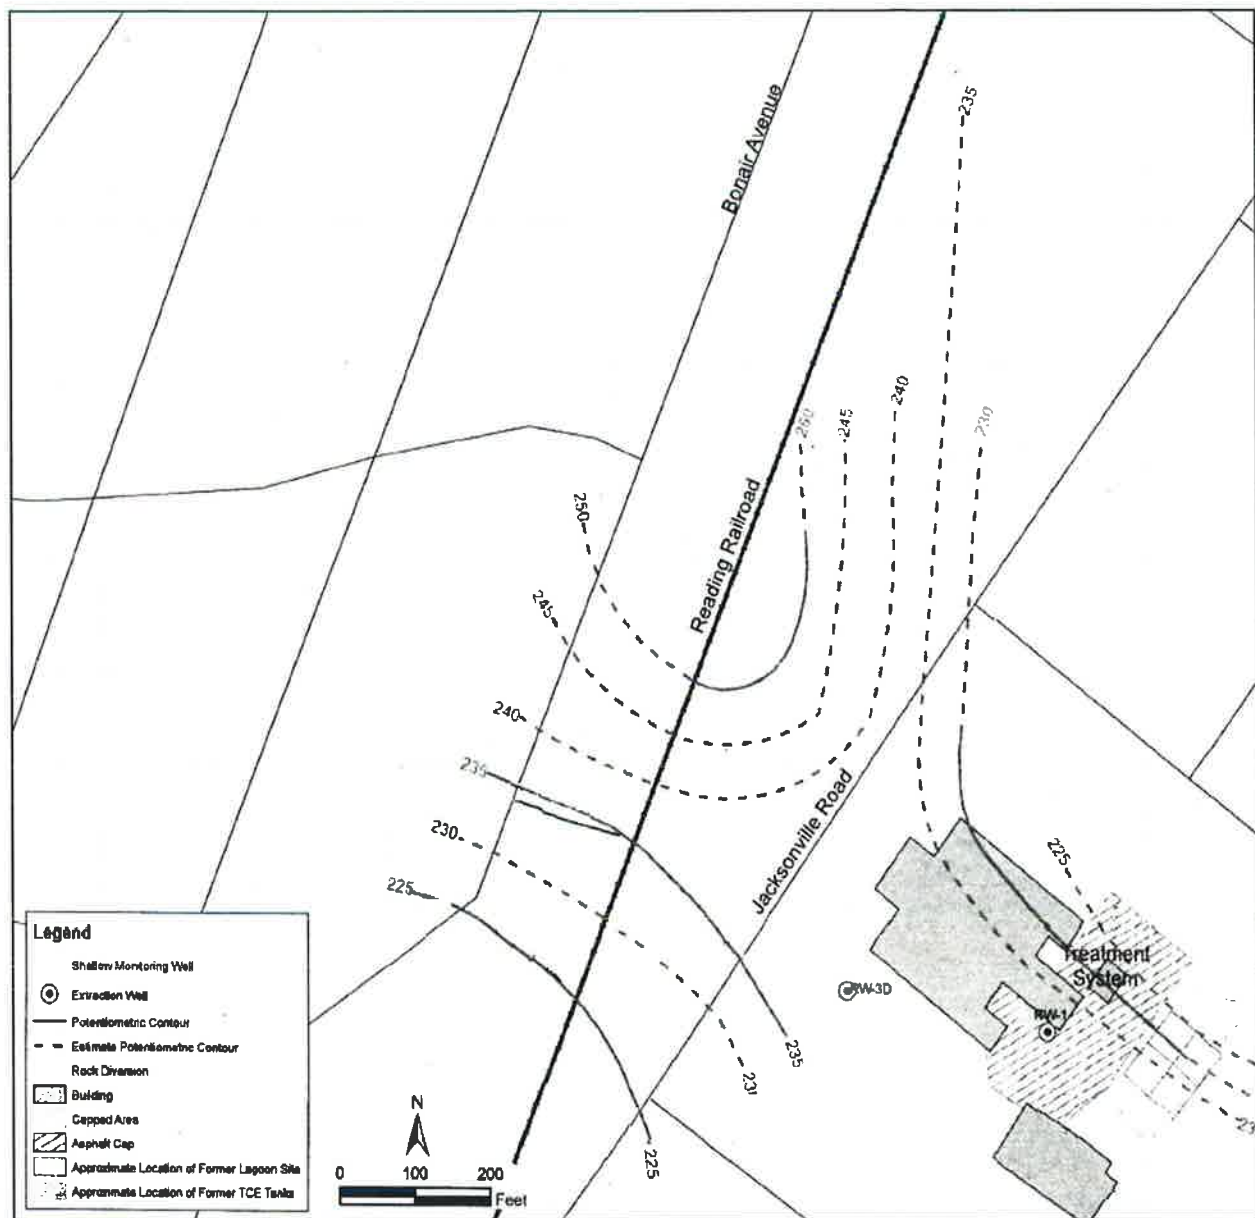
Figure 3. Capped Area and Former Lagoon Areas at the Property

The overall visual inspection of the Site buildings, fenced entryway, asphalt paved areas, low-permeability cap and perimeter fence revealed no damage or deterioration. EPA relied on PADEP's institutional knowledge of the current operations and maintenance of the Site. No issues were identified during the Site inspection.

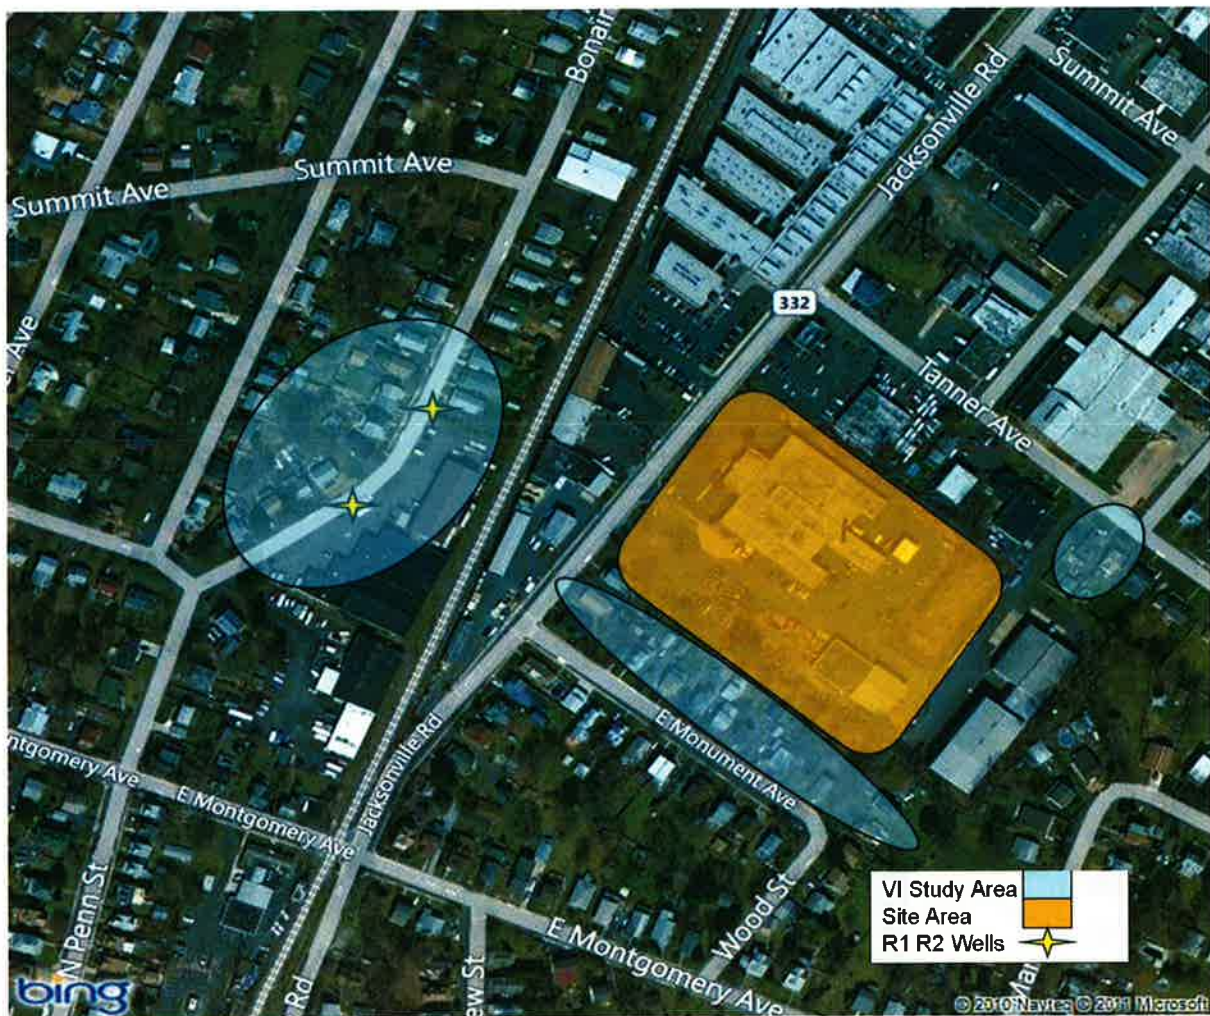
Figure 4. Vapor Intrusion Study Area and Former Area of Contamination

Several of the properties that were sampled showed evidence of actual or potential vapor intrusion of Site COCs. Analytical data revealed that the highest concentrations of COCs found in subslab vapor occurred at properties along Bonair Avenue. Regardless of this, VI it is not a current threat for human health due to the low concentrations found at those residences. It could potentially be in the future; therefore, further investigation efforts are warranted.

In order to address these issues, it is recommended that the VI study be expanded to evaluate other residences in the Bonair Avenue vicinity. Bonair Avenue was the location where the highest concentrations of COCs were found in the subslab during the VI study. Additional sampling is planned to be completed in late 2014 (October to December) and early 2015 (January to March).
